# Mercedes W123 Fuel Filler Neck Seal Replacement

The fuel neck of the tank on your W123 passes through the rear fender in to the fuel filler opening. There is a rubber seal around the fuel neck to prevent water, dirt, and fuel drips from entering the trunk. Learn to replace it.

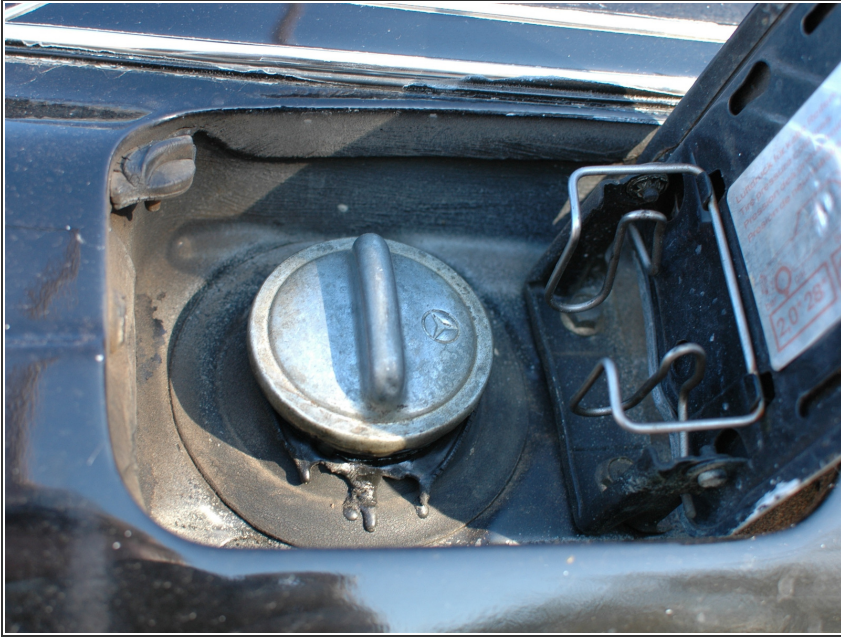
## Step 1 — Fuel Filler Neck Seal

- When inspecting your fuel filler neck seal look for dryness, brittleness, or like on this particular diesel W123 obvious damage. This was caused by drips of B99 biodiesel on the already aged rubber seal.

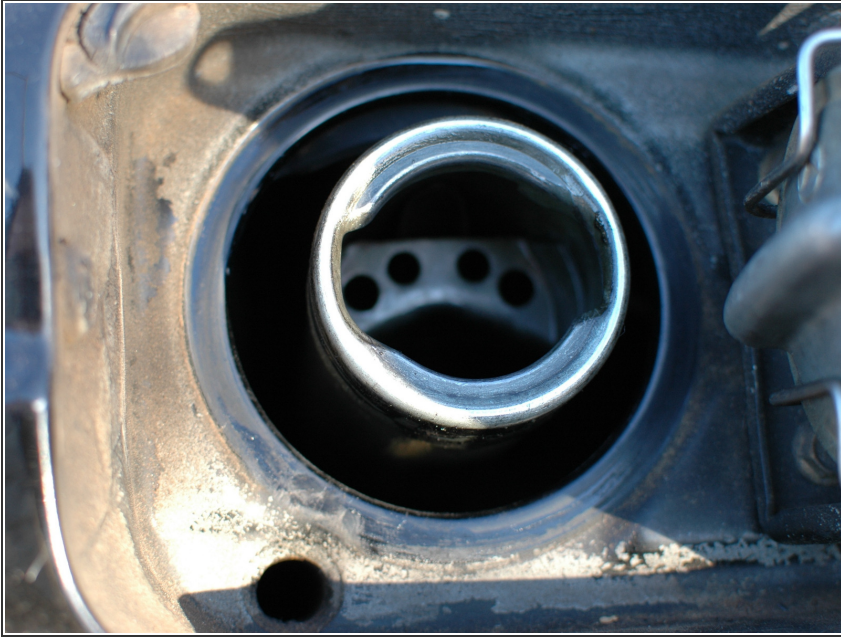
### Step 3

- Pull the seal off of the fuel filler neck. It will look like this once the seal is off.

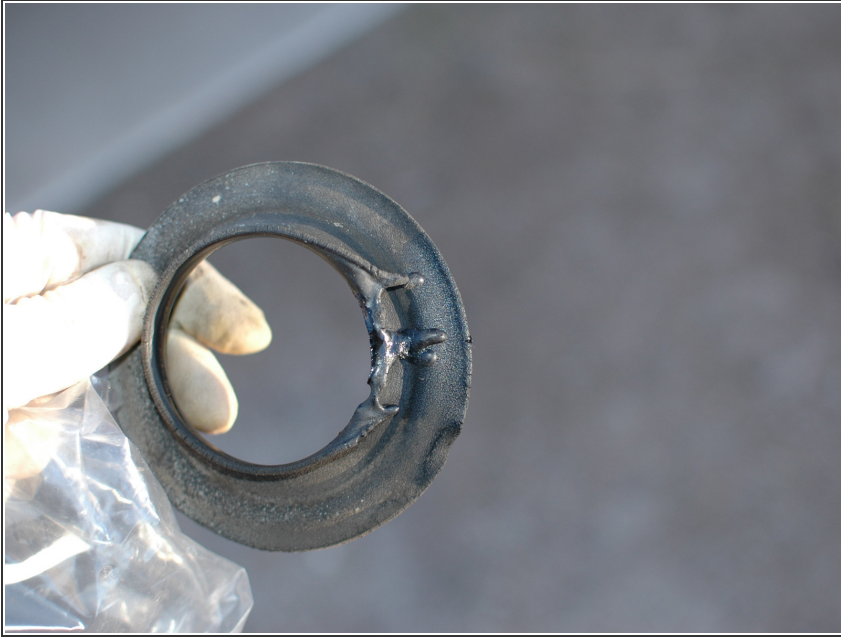
## Step 5

- Here's one last look at the damage done by the biodiesel. The owner of this W123 will be more careful in the future not to drip fuel on the filler neck seal when filling with B99; at that concentration, biodiesel is very caustic to rubber. Lesson learned!

Once finished, consider covering the rubber seal in a light coating of silicone grease to help preserve it.
